Correcting 'Check Grinder' error on HLF 700 Series

Appendix: Replacing the white plastic gear.

Part #9IAMB3055

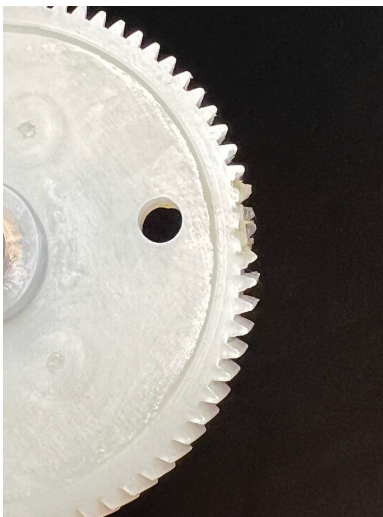
Early versions of the grinder module (those using conical blades) used a white plastic gear to connect the grinder motor to the blades.

In some cases, a jammed grinder can chew up a couple teeth on this gear allowing the motor to turn without turning the blades.

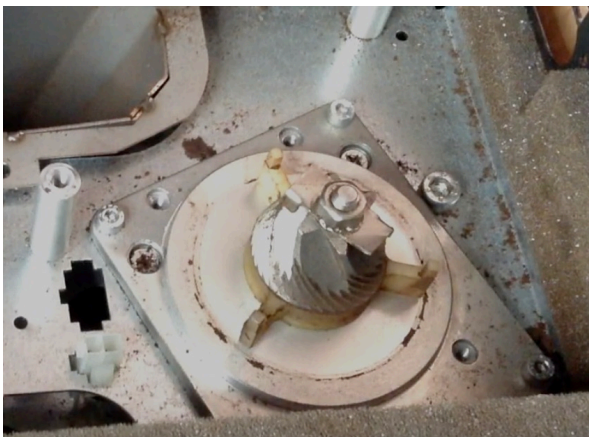
This gear is only found in the modules with conical blades.

To check or replace the gear, first follow the procedure in the video to remove the upper blade assembly.

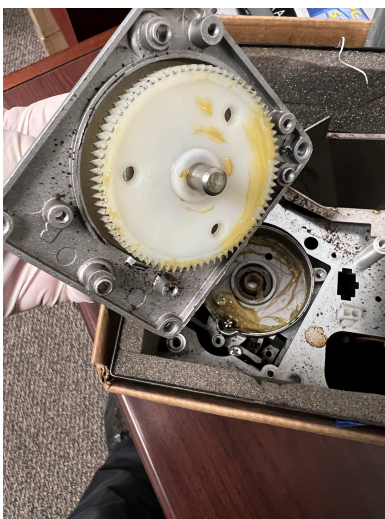
You can now lift the top of the grinders and inspect the white plastic gear.

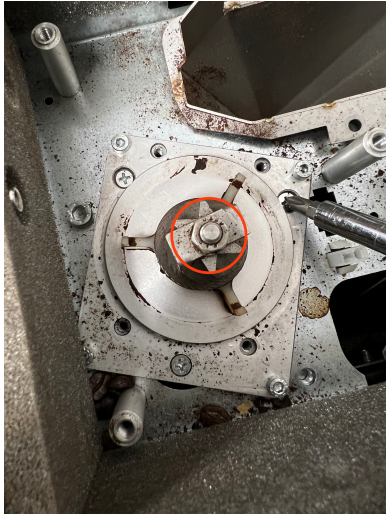
If replacement of the gear is needed, remove the lower blade from the spindle with a 10mm socket. Note: this is a reverse thread. Turn clockwise to remove.

As you remove the nut, lock washer, blade, etc you will find bushings for the bearings attached to the shaft. Be sure to note the order and replace it all in the same order when reassembling.
